# YOUR INSPECTION REPORT

RE: Report No. 1050

This is an attractive apartment building built in 1929. It appears to have been well maintained over the years. However, no building is without issues. And this one is no exception.

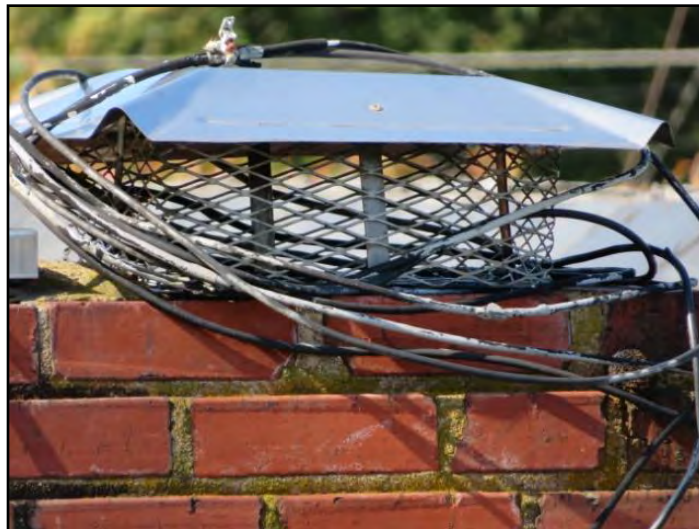
1.

**1. Condition:** • Safety issue: There is what appears to be cable wiring wrapped around the spark arrester of the chimney on the east side of the building. This is a potentially serious safety issue, that could result in a fire. I recommend having it removed.

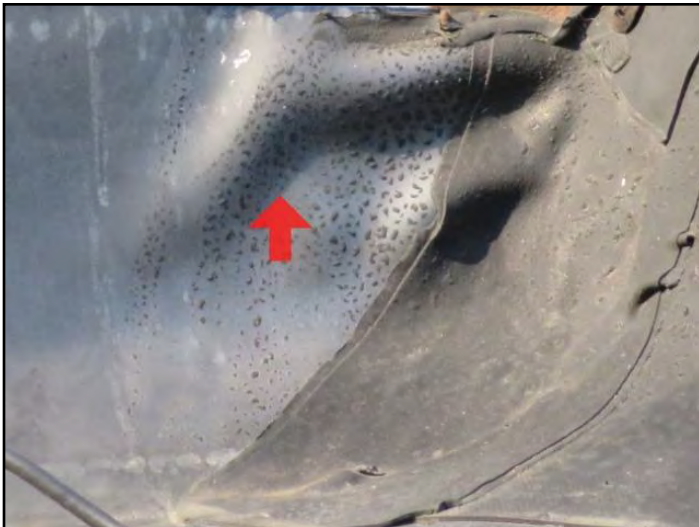
3. *Blisters*

Monitor: There are a couple of spots on the flat roof that show visible blisters, these areas should be monitored in the future for possible leaks.

**Implication(s):** Chance of water damage to contents, finishes and/or structure

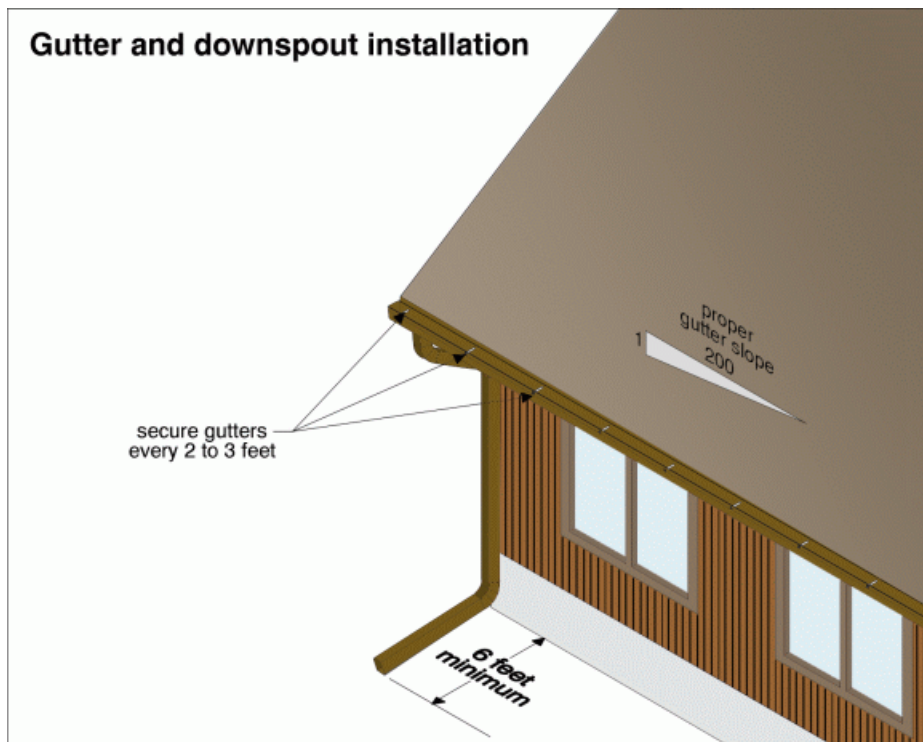
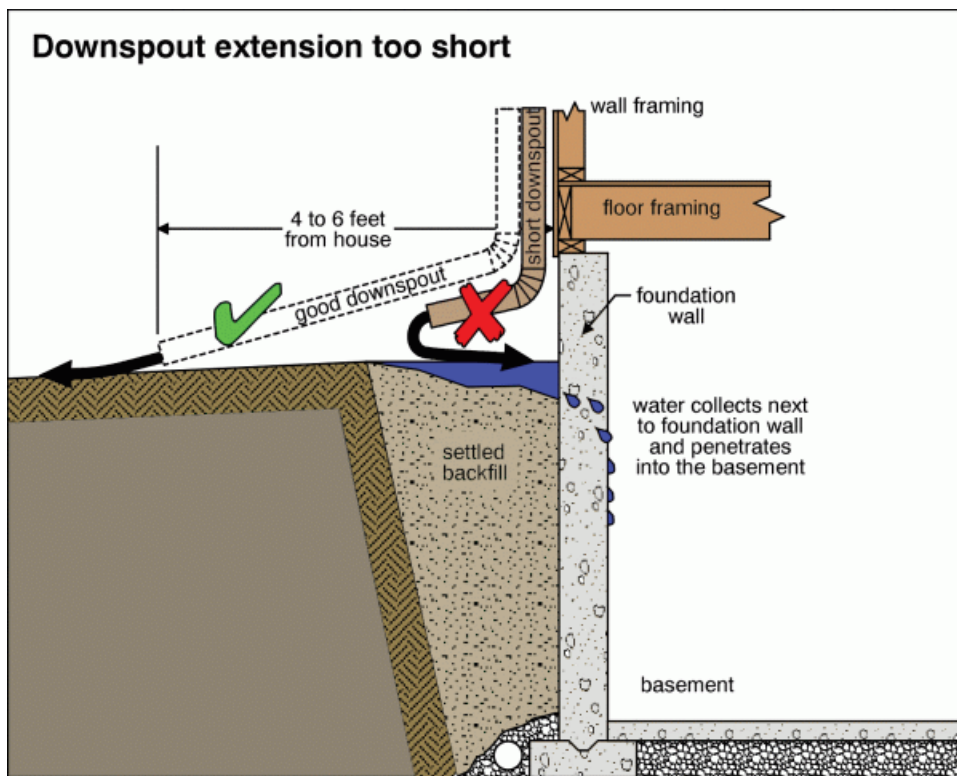
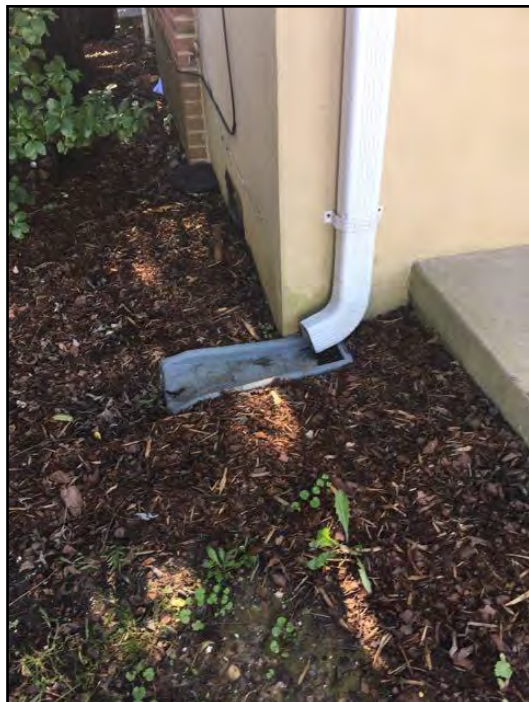
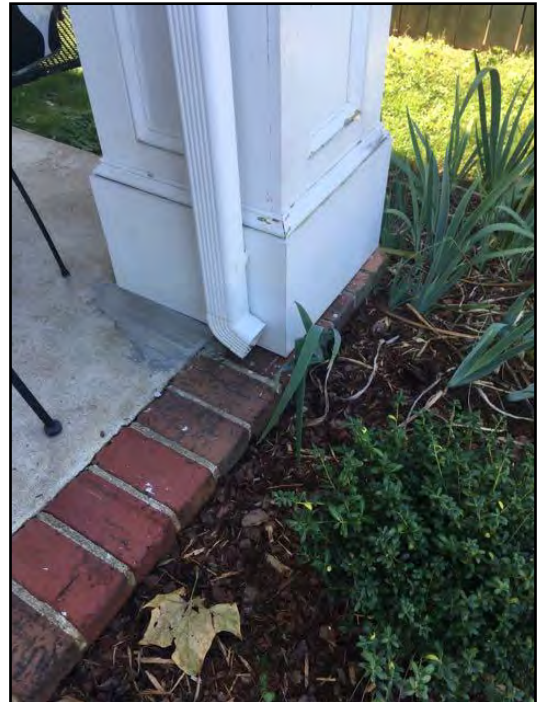
**4. Condition:** • [Discharge too close to building](#)

**Monitor:** The above grade downspouts in the front of the building discharge up against the foundation. I recommend extending them at least 5 feet away from the building.

**Implication(s):** Chance of water damage to contents, finishes and/or structure

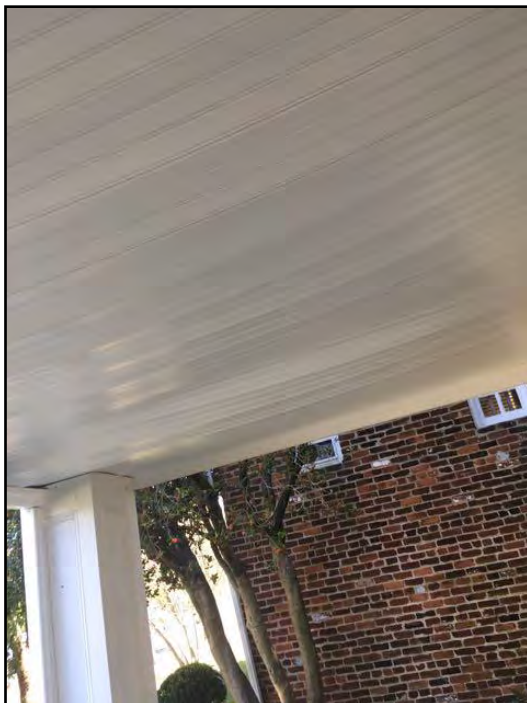
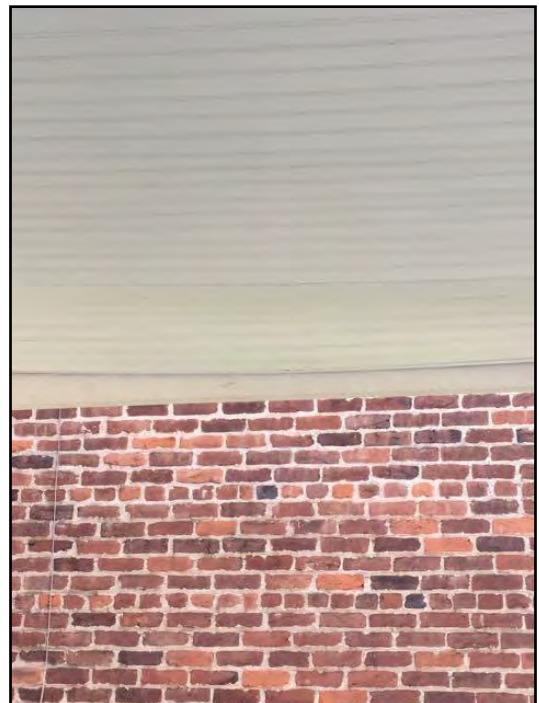
5. **Condition:** • Monitor: The front porch soffit shows visible signs of sagging. However there appears to be a low risk of system failure.

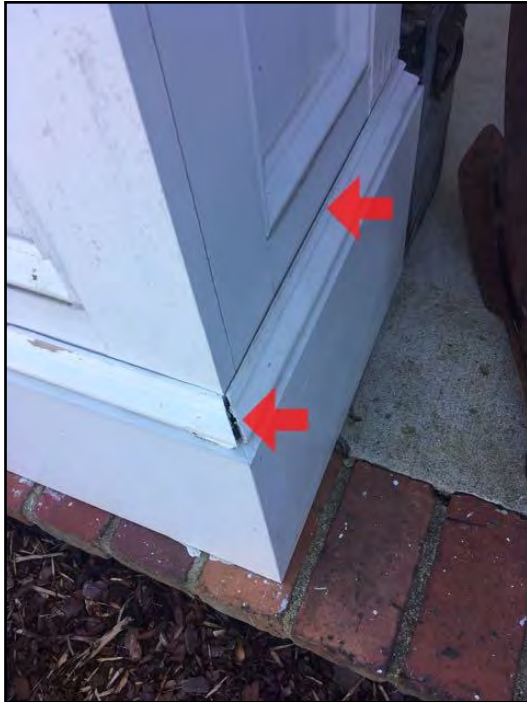
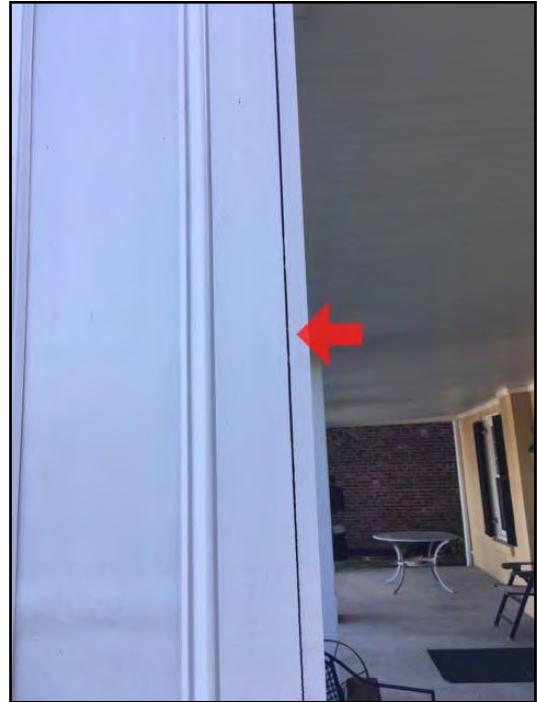
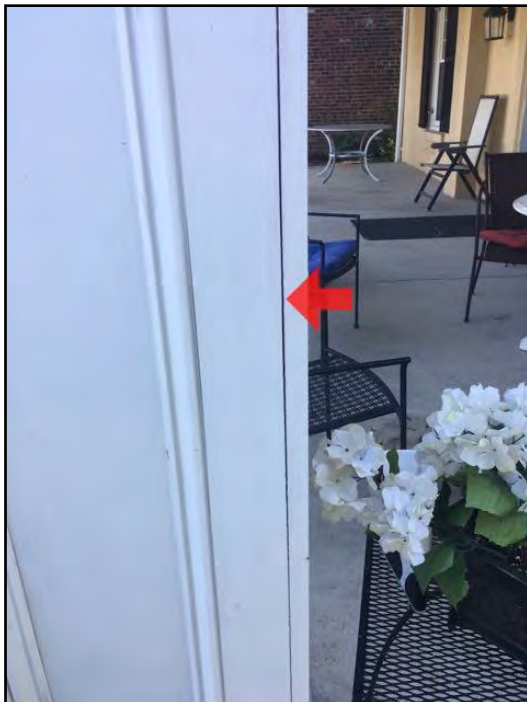
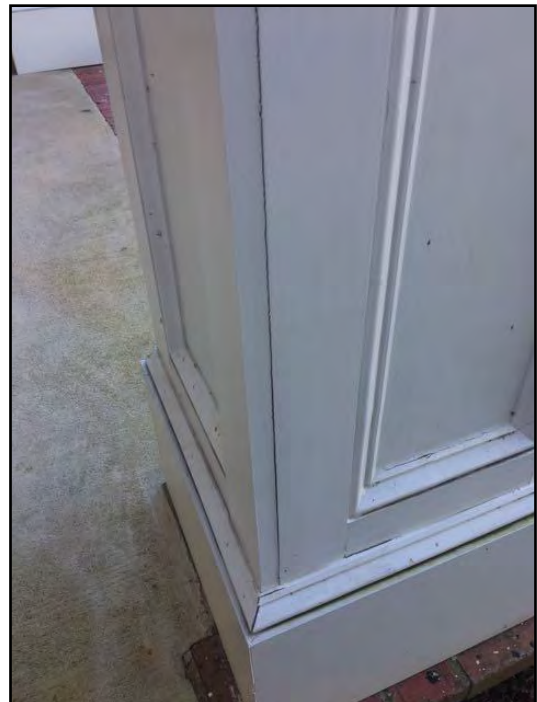
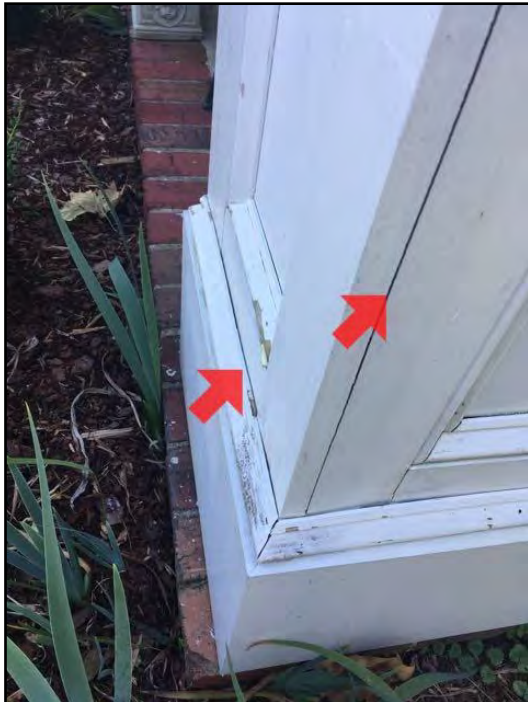
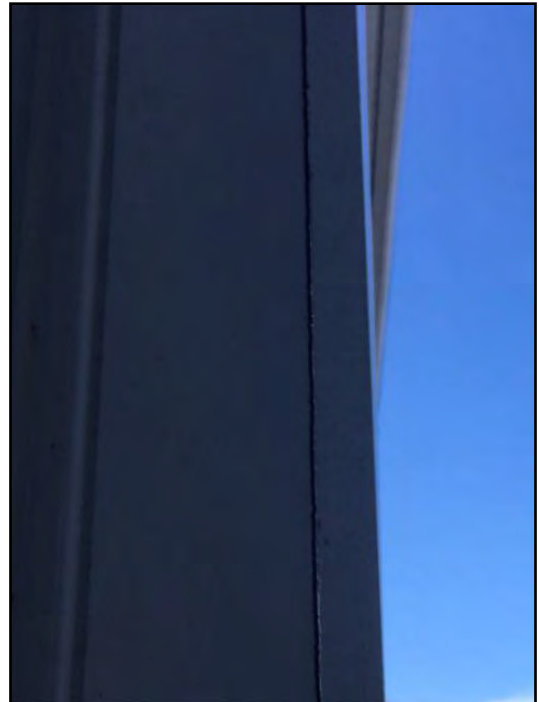
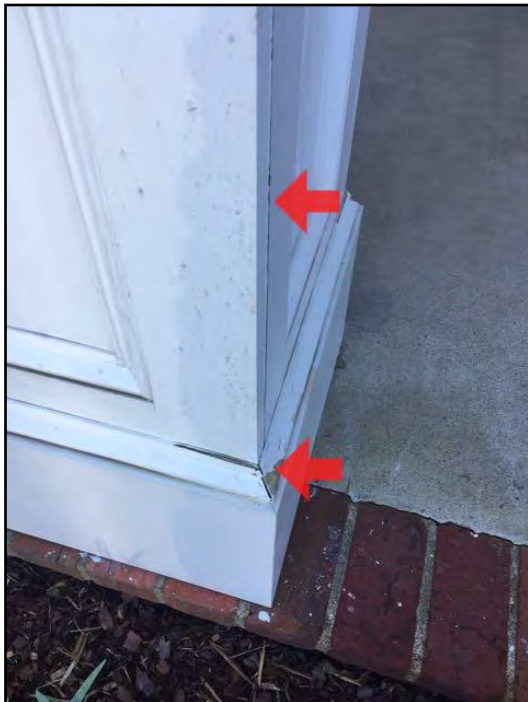
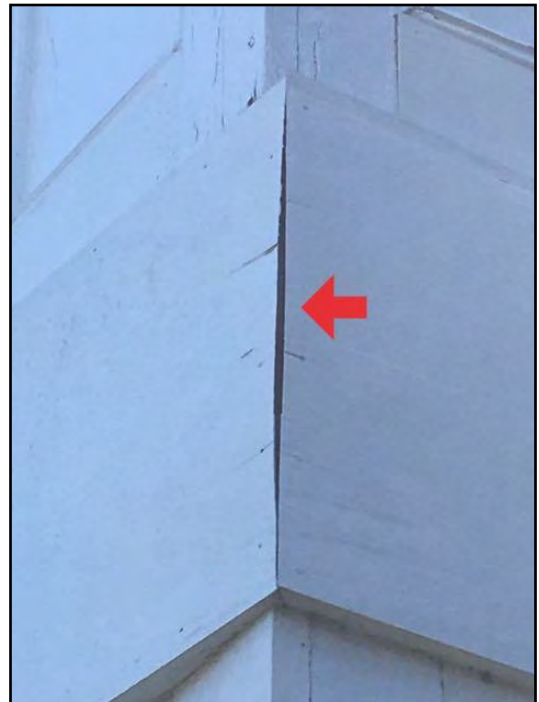
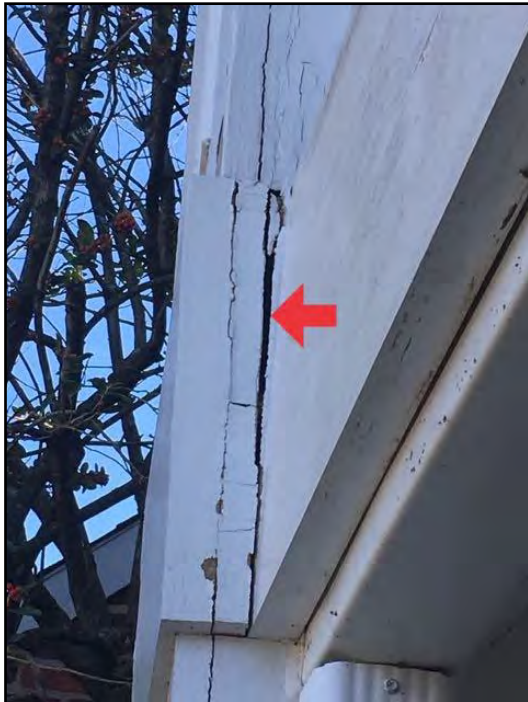
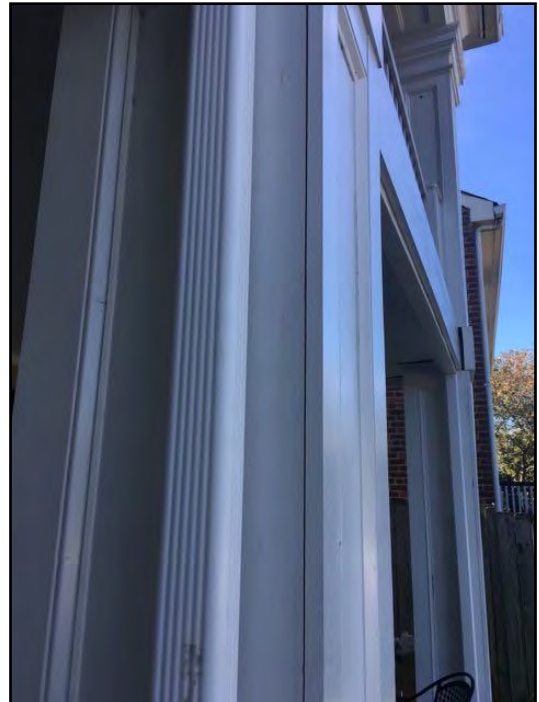
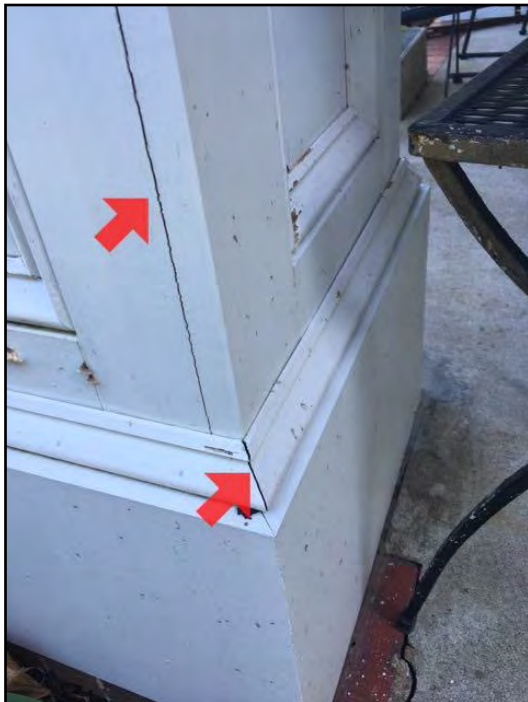
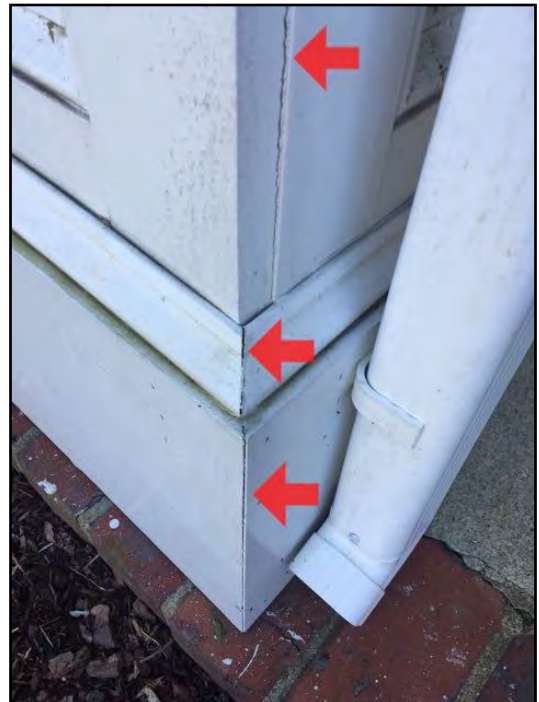
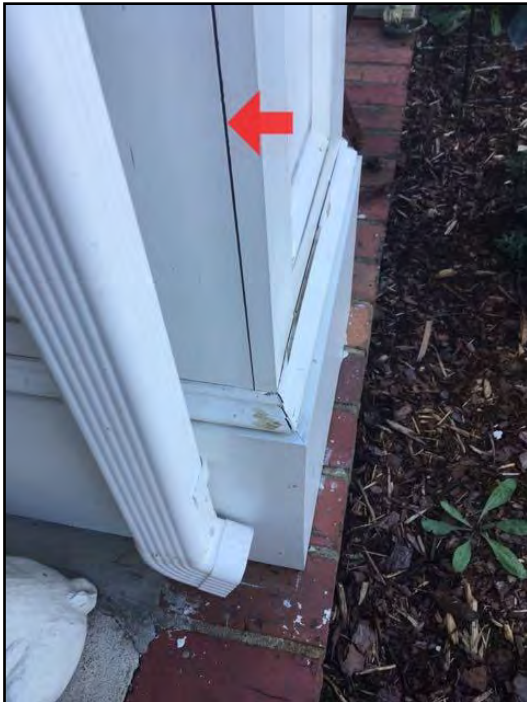
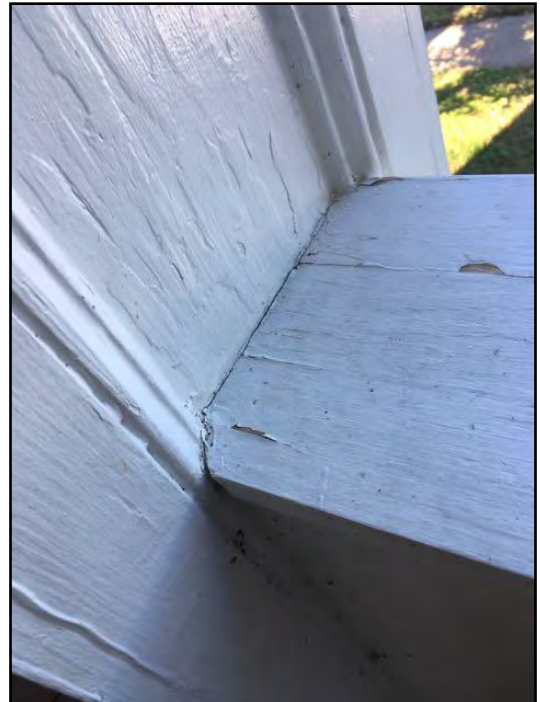
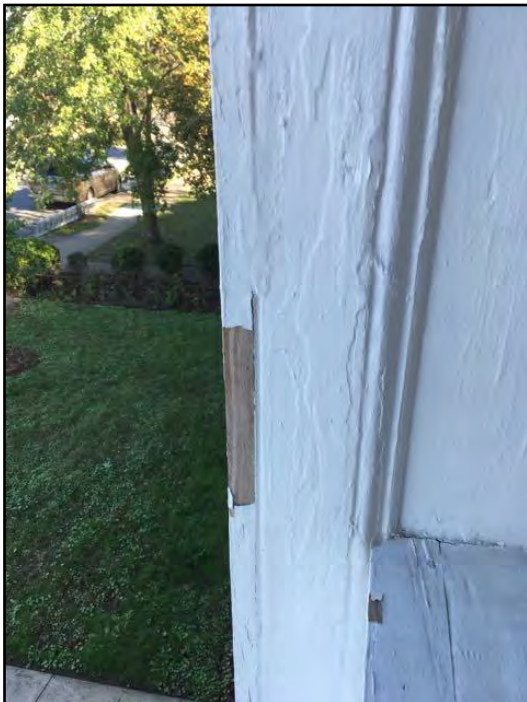
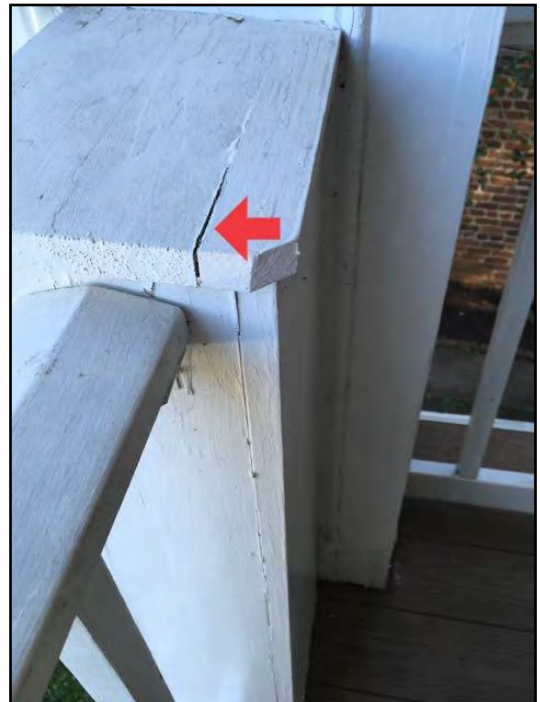
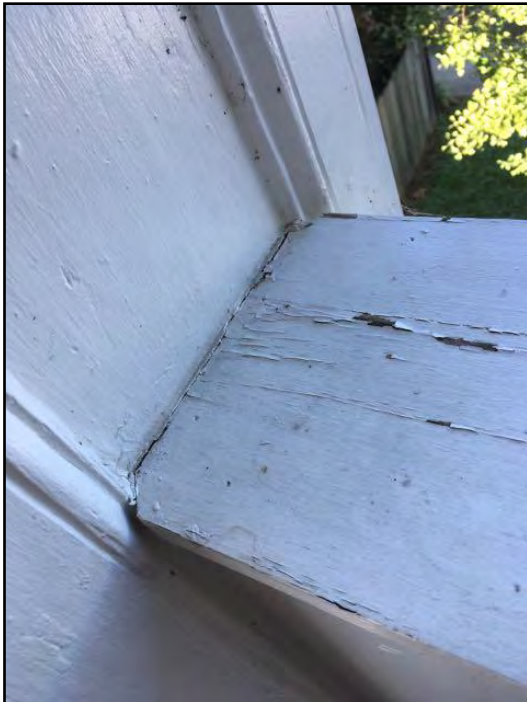
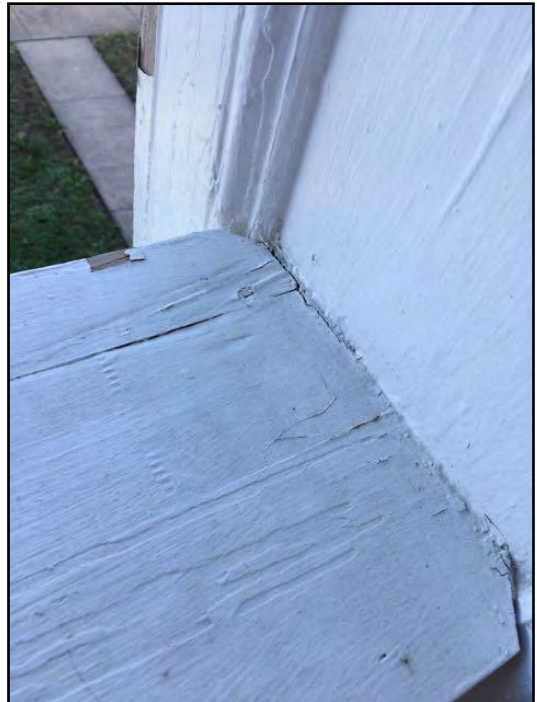
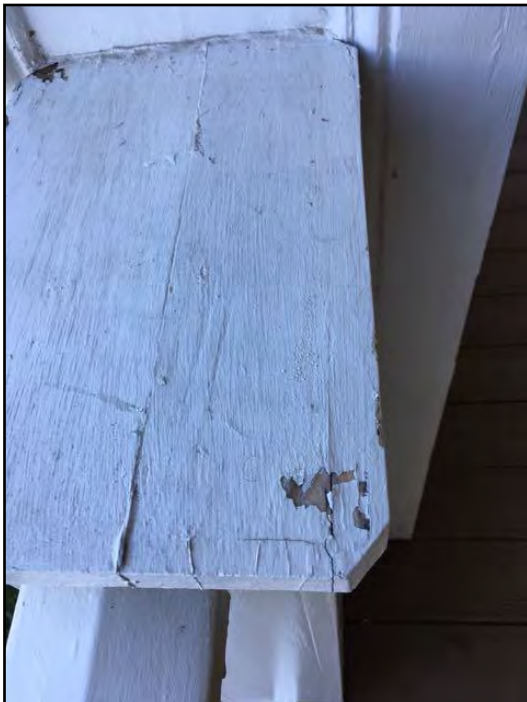
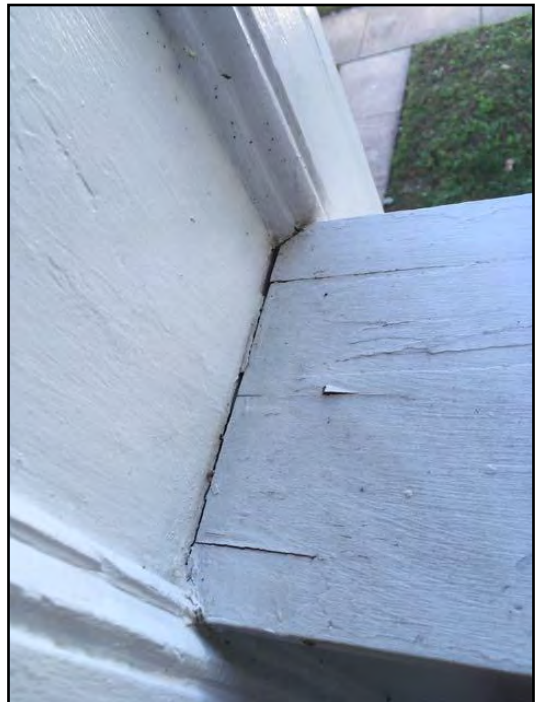
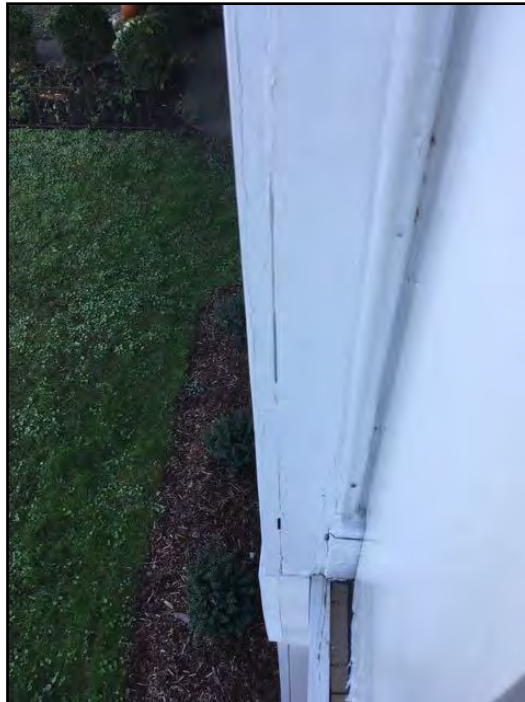
### 6. Condition: • [Caulking missing or deteriorated](#)

Repair: The front porch columns need caulk in various places. This is a cosmetic issue, however if left unattended can lead to material deterioration. Paint is also needed in various places.

**Implication(s):** Chance of water damage to contents, finishes and/or structure | Material deterioration

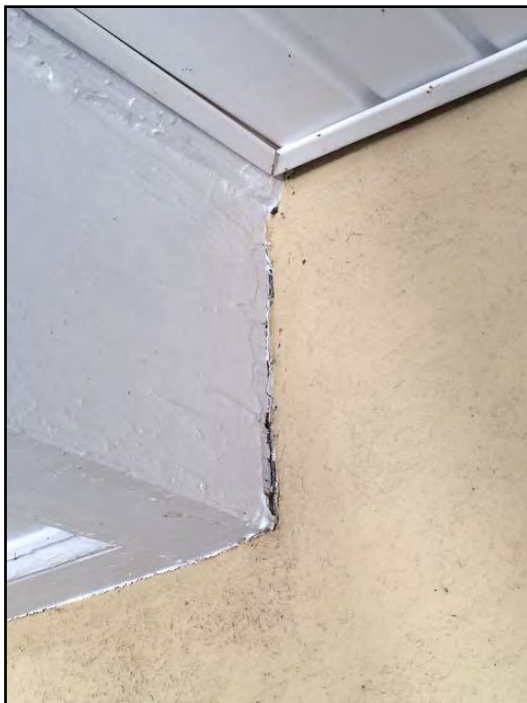
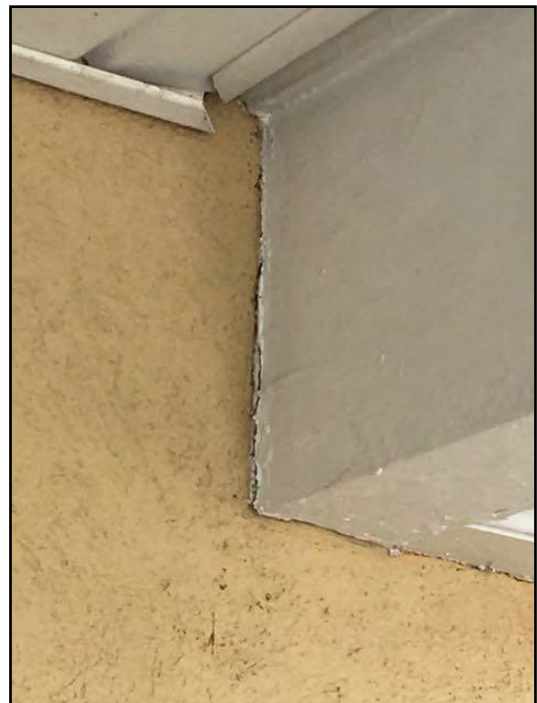
**7. Condition:** • [Caulking missing or deteriorated](#)

There are couple places where the beams meet the exterior wall on the upper porch that need caulk. Cosmetic issue.

**Implication(s):** Chance of water damage to contents, finishes and/or structure | Material deterioration

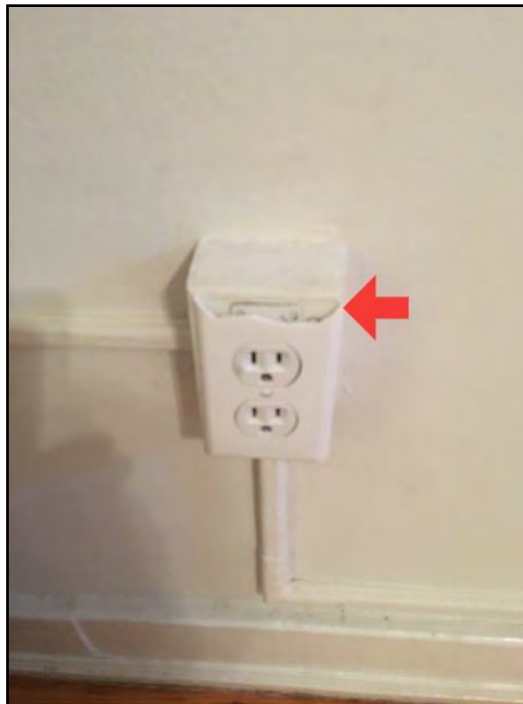
37. Damage

**DISTRIBUTION SYSTEM \ Outlets (receptacles)****9. Condition:** • [Damage](#)

Safety issue: Unit number one. Damaged outlet cover in living room on the left as you enter the living room. Recommend replacement.

**Implication(s):** Electric shock | Fire hazard

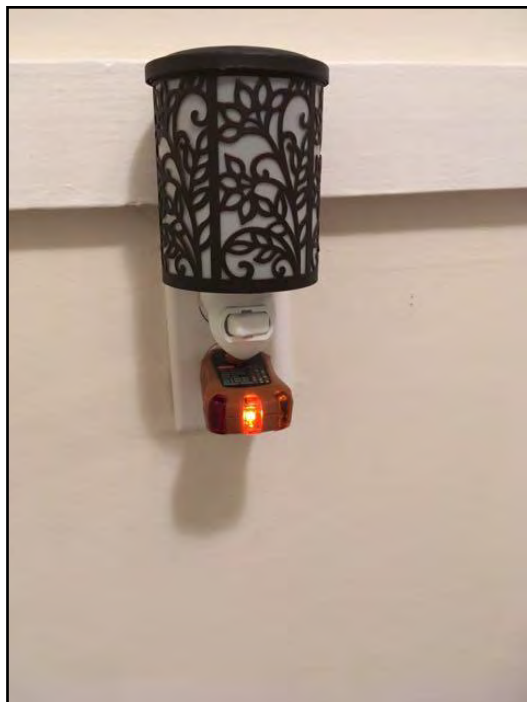
38. Ungrounded

**10. Condition:** • [Ungrounded](#)

Safety issue: Unit number one. One of the receptacles in the bedroom shows an open ground. There is also an outlet in the dining room within an open ground. This is a safety issue. Recommend having them checked out by a licensed professional electrician.

**Implication(s):** Electric shock

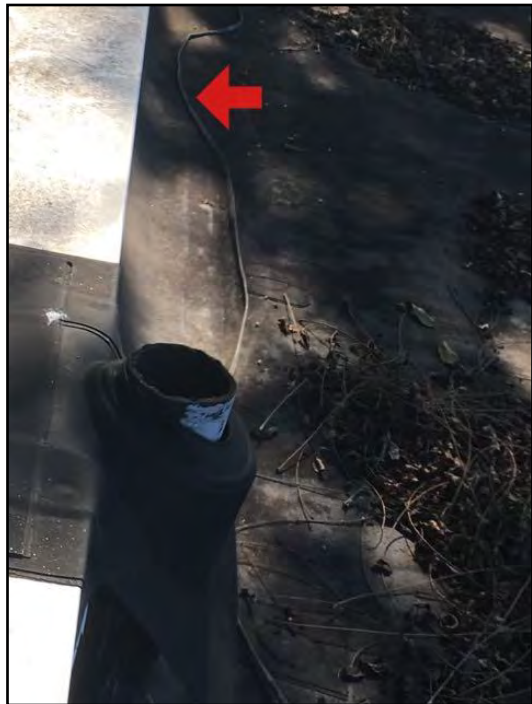
40.

There is safety issue regarding a wire that supplies power to an exterior security light on the upper level of the east side of the building.

**11. Condition:** • Safety issue: The wire supplying power to the exterior security light on the east side of the building is not properly housed. This is a potential serious safety hazard. I recommend having it checked out by a qualified professional electrician. Standards call for wiring to be housed inside of proper external conduit.

I recommend having a qualified electrician look at it. You will find details further into this report.

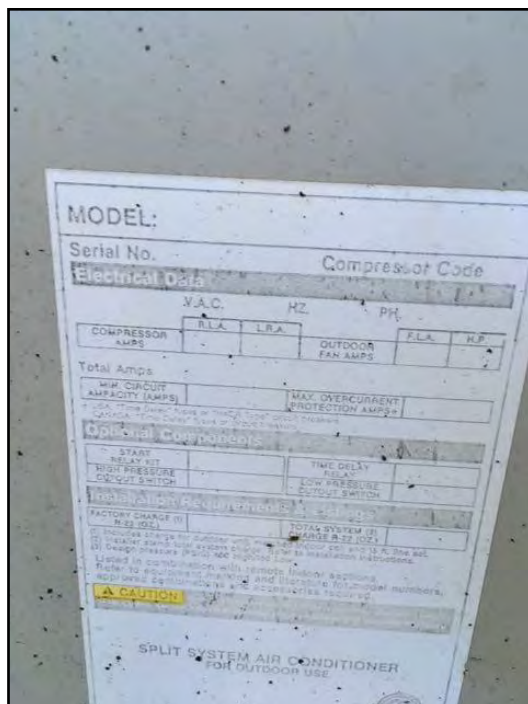
**General:** • Monitor: I was unable to determine the age of each units heat pump due to a lack of legible information on each data plate. I recommend having each heat pump unit checked out by a qualified hvac specialist.

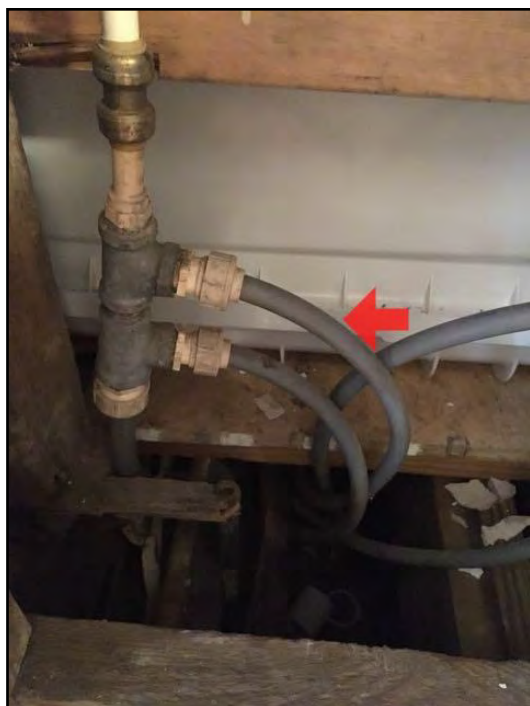
50. Suspect polybutylene connections

There is an issue regarding expense with the plumbing supply lines. These lines are PB lines (polybutylene). They are gray in color and have been known to fail unexpectedly. You will find details further into this report.

**12. Condition:** • [Suspect polybutylene connections](#)

Monitor: Unit number four. Polybutylene water supply line has been known to fail prior to the end of its life expectancy. Highly recommend monitoring the supply lines. They are considered to be inferior and should be replaced.

**Implication(s):** Chance of water damage to contents, finishes and/or structure

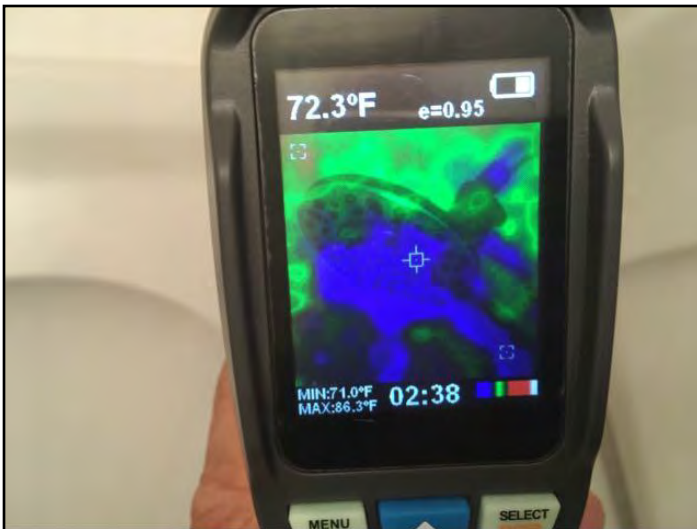
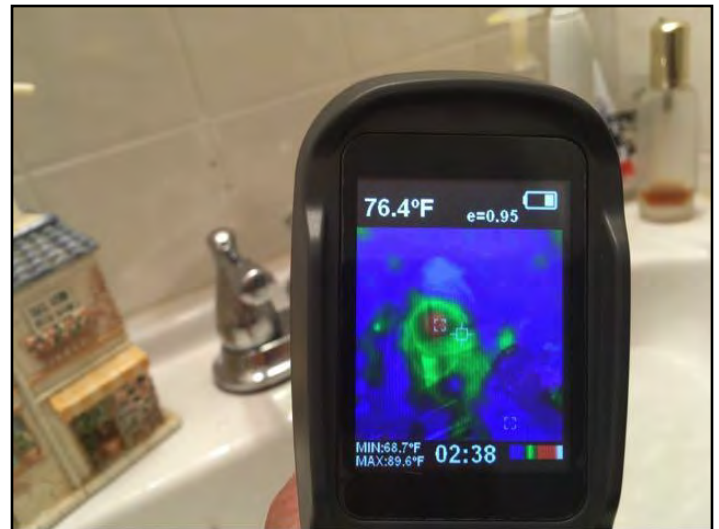
One of the most important issues regarding comfort is the fact that the water in the hot supply lines to all four of the units does not reach a recommended temperature after having been run through the line for more than 10 minutes. I was unable to visually inspect the water heater due to the fact that it is stored in the shed in back of the unit, which was locked and no entry key was provided by the listing agent. I suggest that the water heater be checked by a qualified specialist. Details are noted further into this report.

**13. Condition:** • Monitor/adjust: I ran the hot water in the bathroom of unit two for nearly 10 minutes. The water temperature never went above 77°. Recommend adjustment of water heater temperature. This condition exists in all four units.

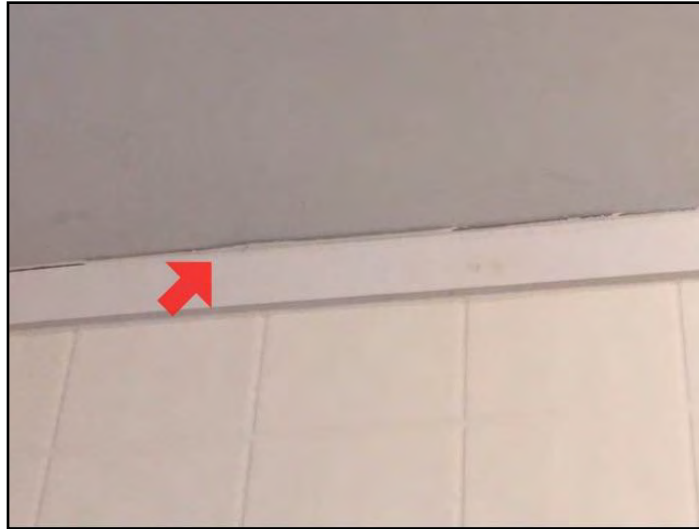
82.

**15. Condition:** • Repair: Unit two bathroom cosmetic issue. Trim needs caulk in bathroom of unit number two.

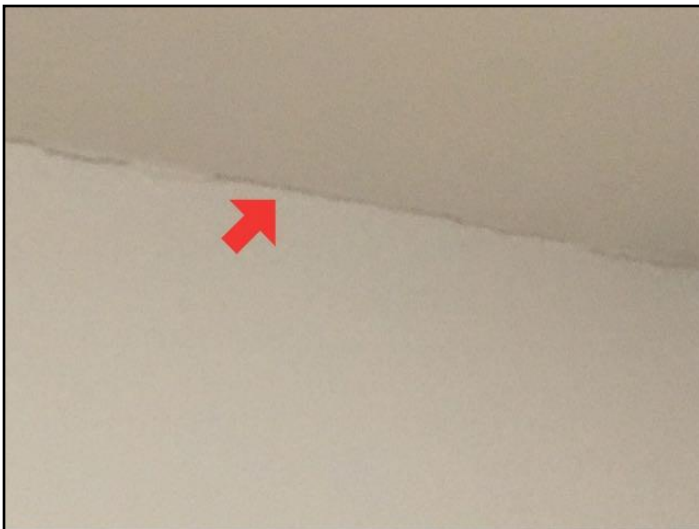
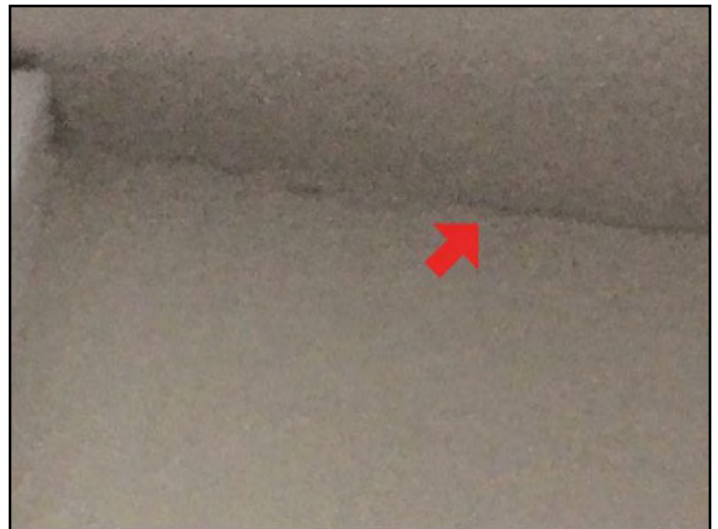
**16. Condition:** • Repair: Unit number four. Visible crack where ceiling meets the wall in the living room on the right as you come through the front door. Cosmetic issue. Recommend repair.

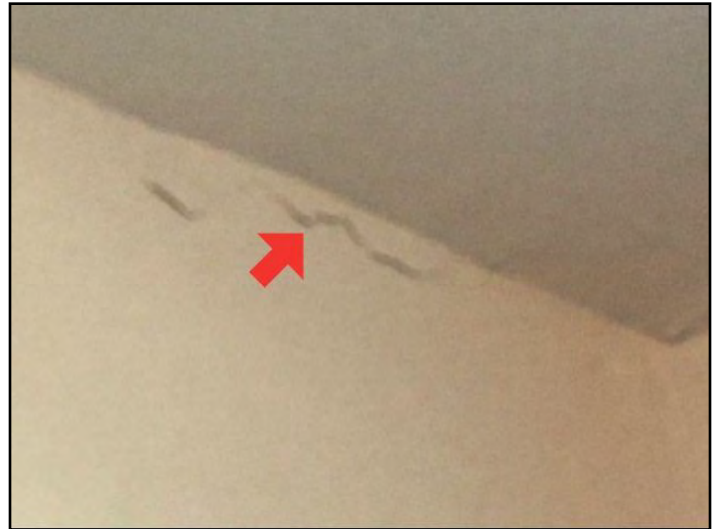
86.

**17. Condition:** • Repair: Unit number three. Cosmetic issue. Visible cracks where ceiling meets the wall above living room window. And in the back left corner left of the window. Recommend repair

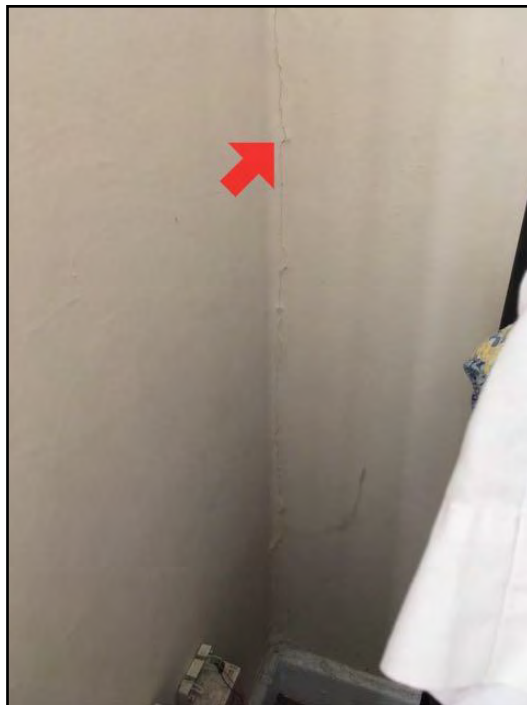
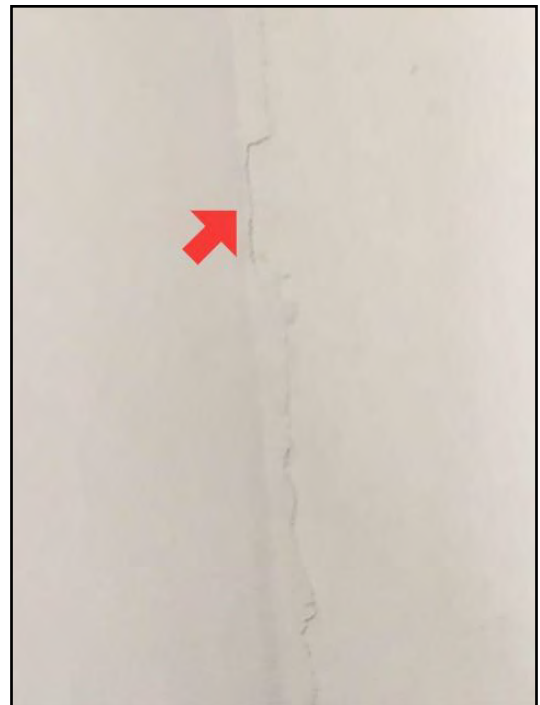
**18. Condition:** • Repair: Unit number two, in the back left bedroom there's a visible crack in the back right corner. Possible water intrusion. Recommend repair

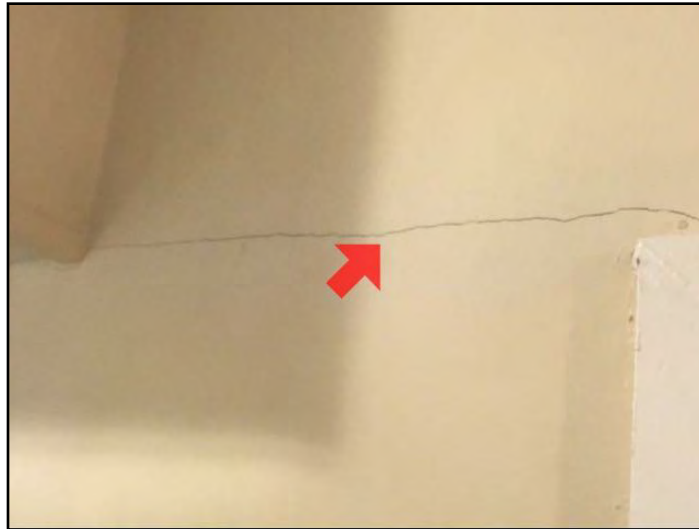
89.

**19. Condition:** • Repair: Unit number two. Visible crack above washer dryer in kitchen. Recommend repair. Cosmetic issue.

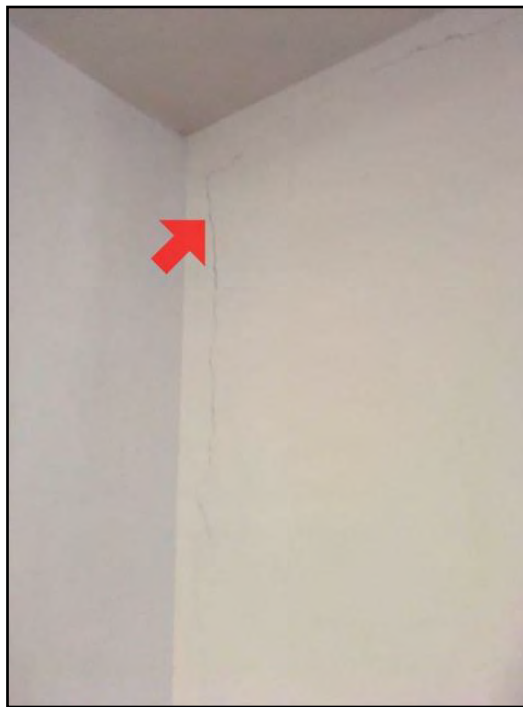
90.

**20. Condition:** • Repair: Unit number four, back right bedroom, there is a visible crack in back left corner, recommend repair. Cosmetic issue.

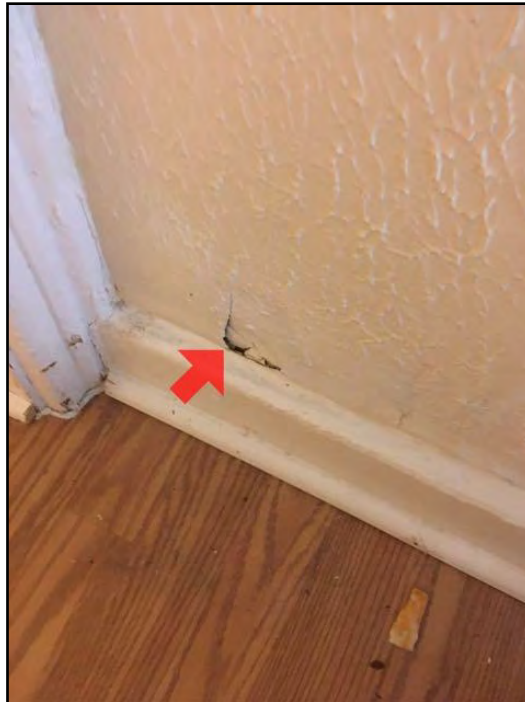
**21. Condition:** • Damaged

Repair: Unit number two. minor damage to drywall/plaster at the bottom left above base trim.

**Implication(s):** Damage or physical injury due to falling materials

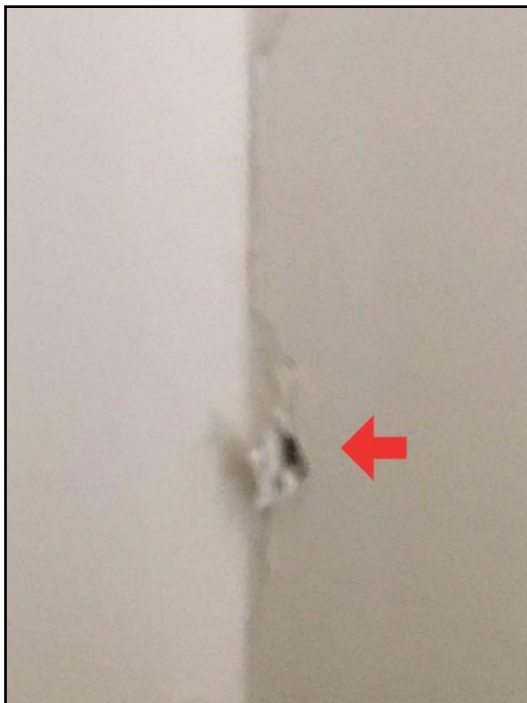
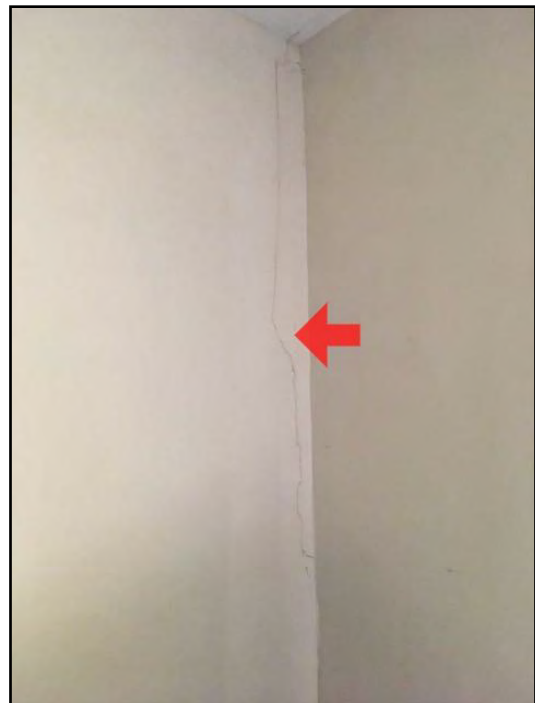
**22. Condition:** • [Cracked](#)

Repair: Unit two. Visible crack and minor damage in the corner of the back bedroom.

**Implication(s):** Damage or physical injury due to falling materials

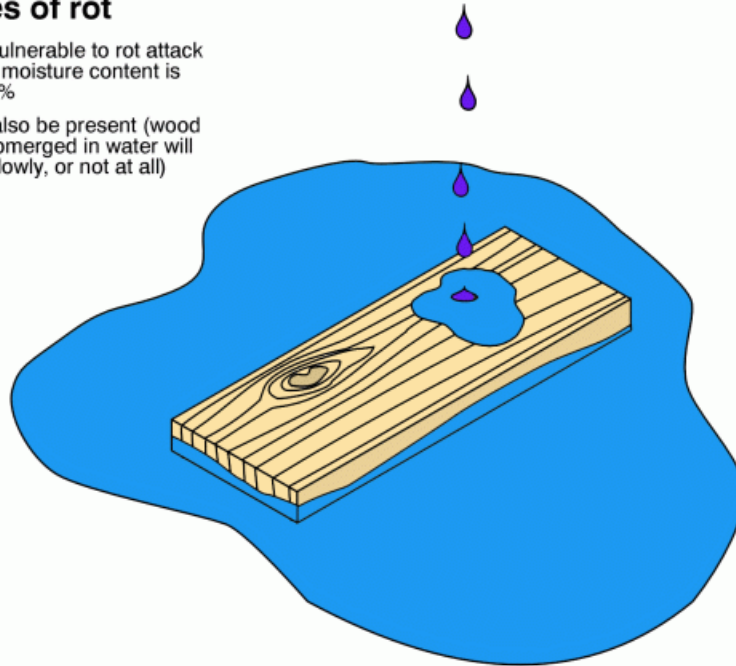
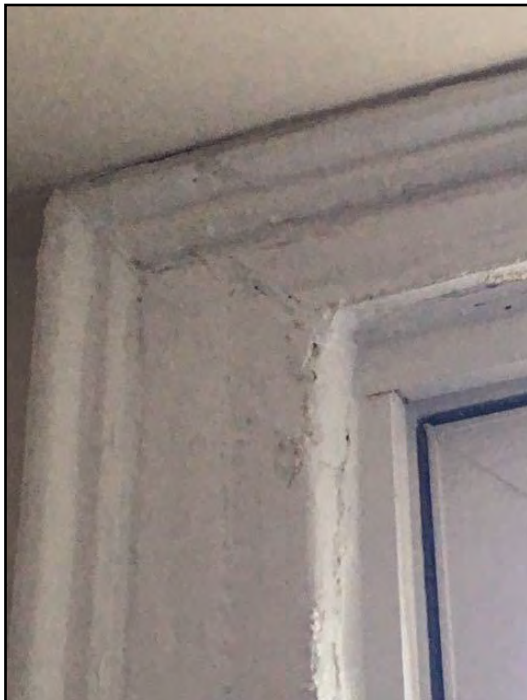
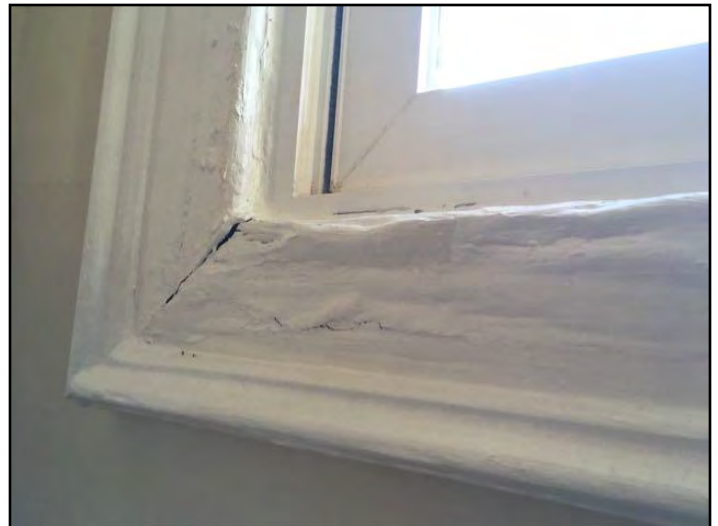
### 23. Condition: • [Rot](#)

Unit number four. Living room window frame shows visible signs of rot and amateur repair. Recommend repair or replacement.

**Implication(s):** Chance of damage to structure | Material deterioration

### Causes of rot

wood is vulnerable to rot attack when the moisture content is above 20%

air must also be present (wood totally submerged in water will rot very slowly, or not at all)

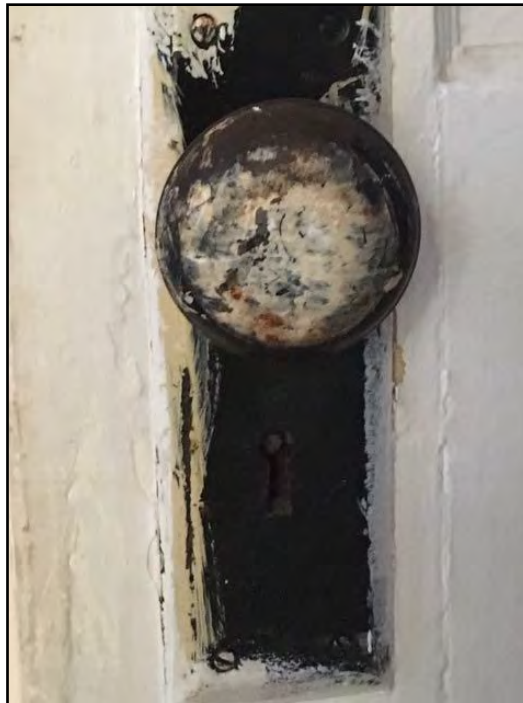
96.

**24. Condition:** • Replace: Bedroom doors are functional. However I was informed by the tenant that there are no keys to any of the interior doors. Recommend upgrading all interior door hardware in all four units.

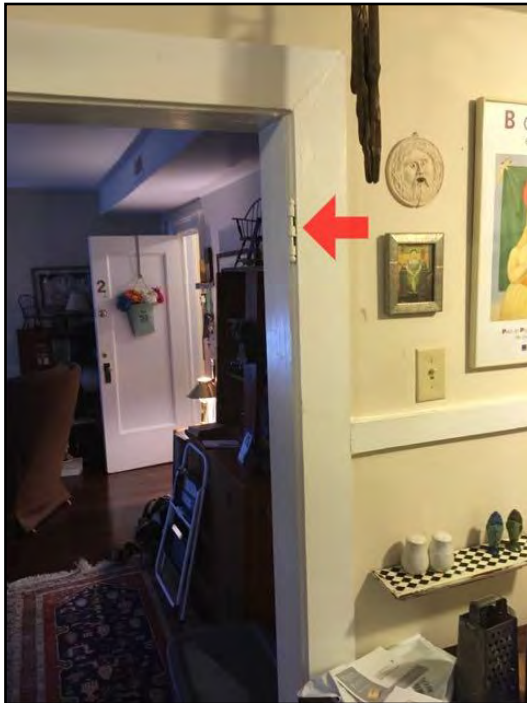
97.

**25. Condition:** • Replace: Unit number two door to dining room entry is missing. I recommend having one installed.
