# YOUR INSPECTION REPORT

RE: Report No. 1050

This is an attractive apartment building built in 1929. It appears to have been well maintained over the years. However, no building is without issues. And this one is no exception.

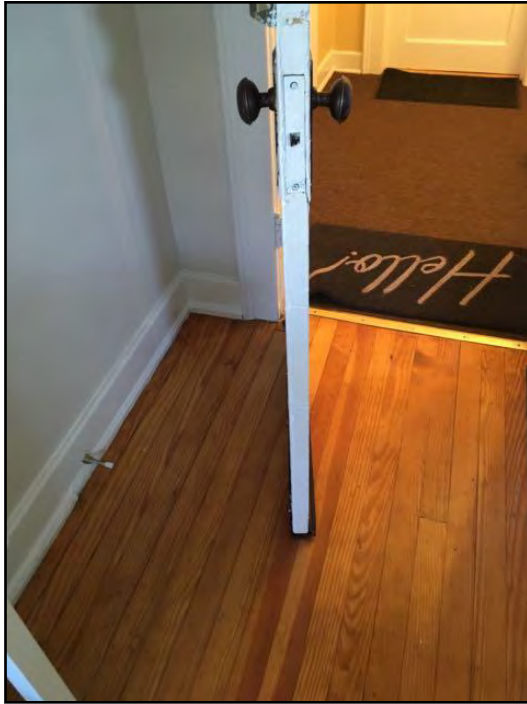
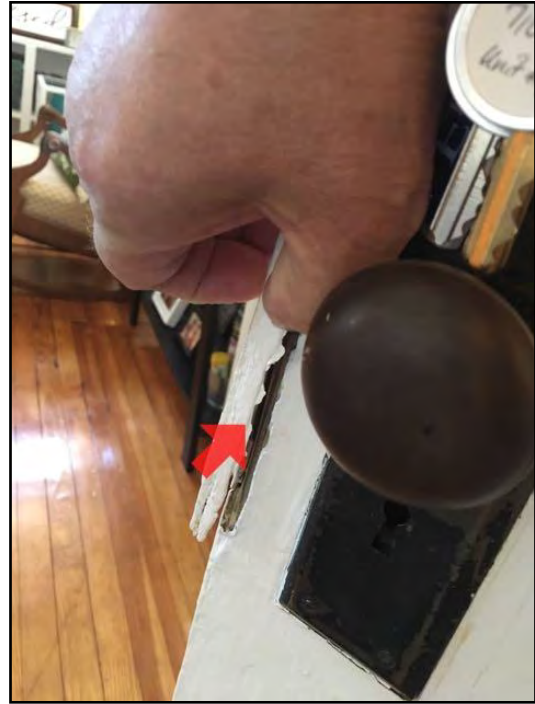
**26. Condition:** • Repair: Unit number four front door does not open completely, it drags tightly against the floor at 2/3rds open. Recommend adjustment. There is also visible damage where the latch mechanism is. Recommend repair.

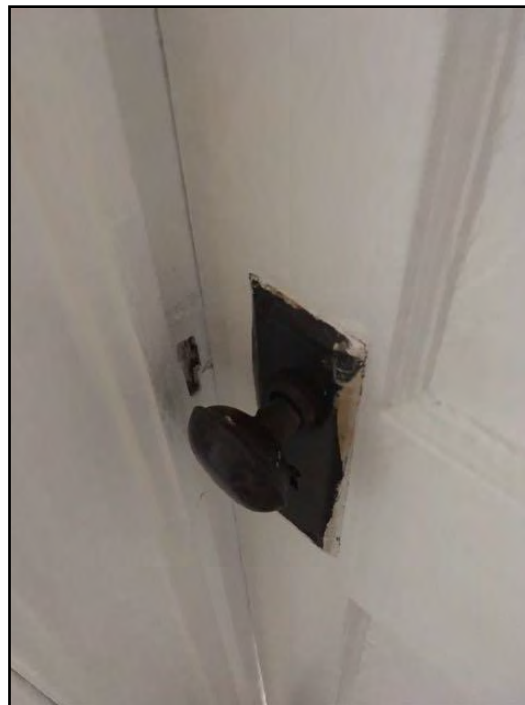
101.

**27. Condition:** • Repair: Unit number four. Bathroom door does not latch completely. Recommend repair.

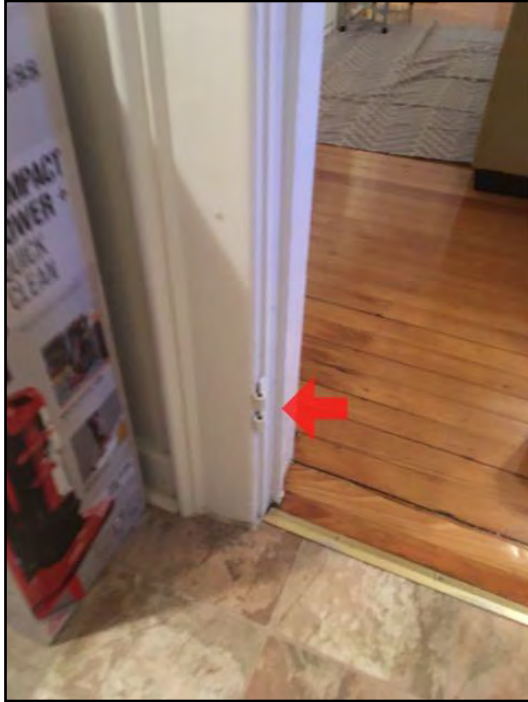
102.

**28. Condition:** • Replace: Unit number one. Entry door to dining room is missing. Recommend replacement.

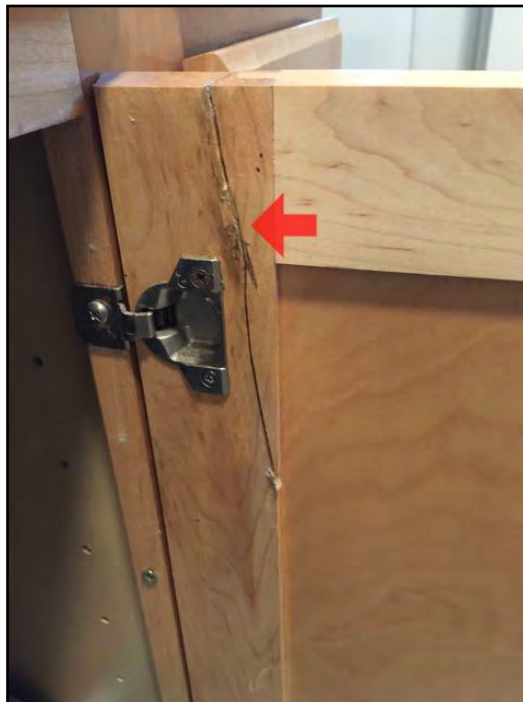
104.

**29. Condition:** • Repair/Replace: Unit number three. cabinet door in front of kitchen sink is damaged. Recommend replacement.
