# YOUR INSPECTION REPORT

RE: Report No. 1050

This is an attractive apartment building built in 1929. It appears to have been well maintained over the years. However, no building is without issues. And this one is no exception.

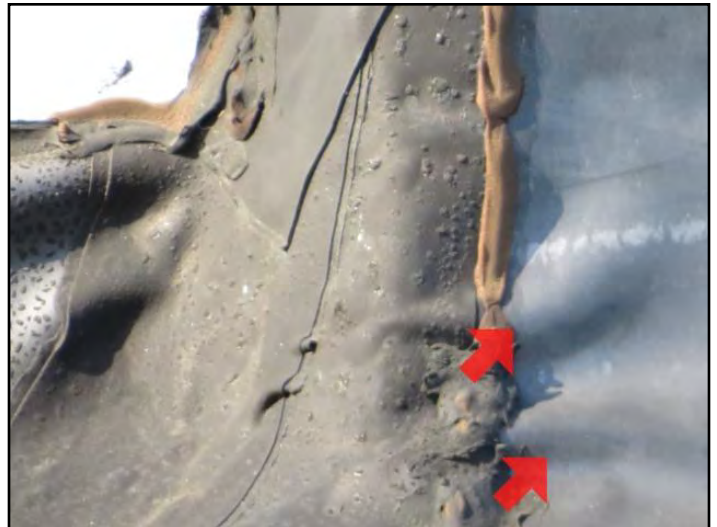
4. *Blisters*

### 3. Condition: • [Blisters](#)

Monitor: There are a couple of spots on the flat roof that show visible blisters, these areas should be monitored in the future for possible leaks.

**Implication(s):** Chance of water damage to contents, finishes and/or structure

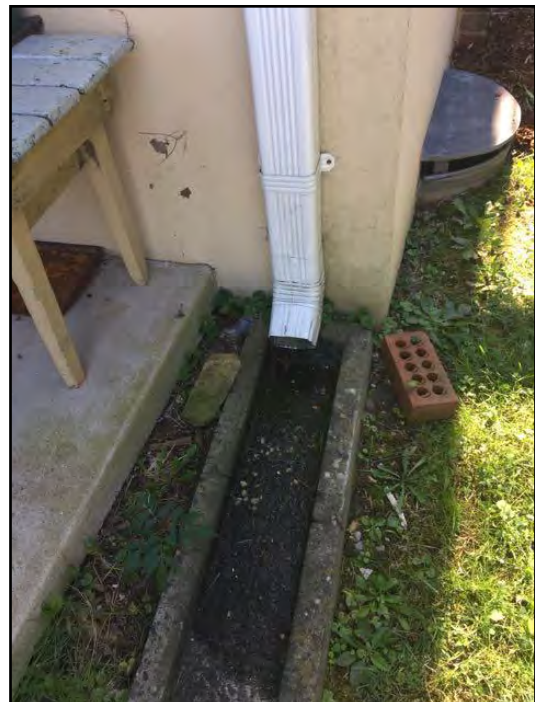
6. Discharge too close to building

**4. Condition:** • [Discharge too close to building](#)

**Monitor:** The above grade downspouts in the front of the building discharge up against the foundation. I recommend extending them at least 5 feet away from the building.

**Implication(s):** Chance of water damage to contents, finishes and/or structure

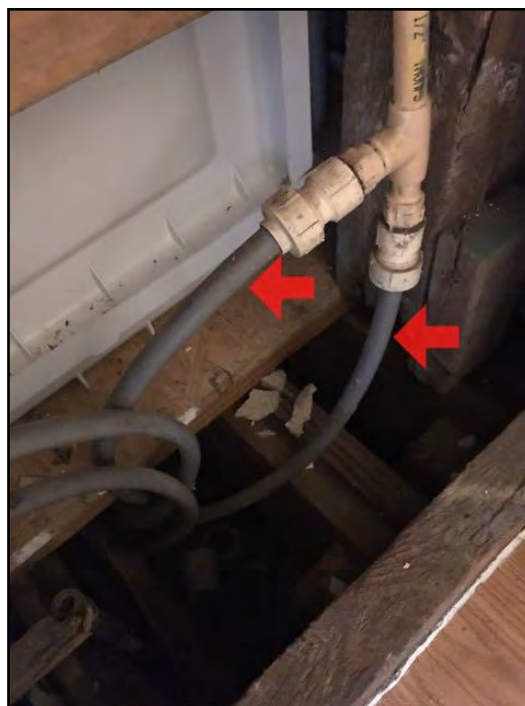
51. Suspect polybutylene connections

There is an issue regarding expense with the plumbing supply lines. These lines are PB lines (polybutylene). They are gray in color and have been known to fail unexpectedly. You will find details further into this report.

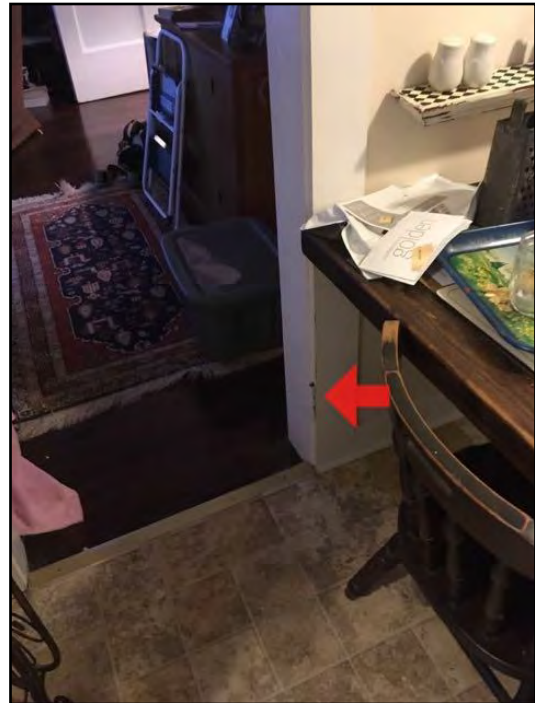
98.

**25. Condition:** • Replace: Unit number two door to dining room entry is missing. I recommend having one installed.

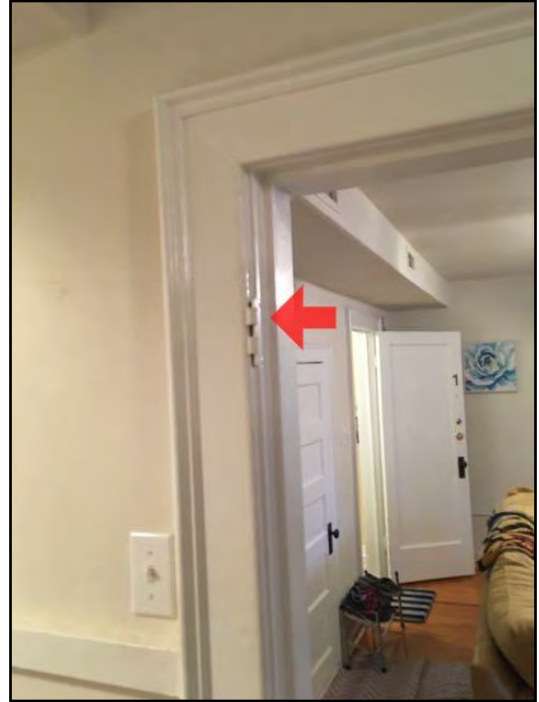
103.

**28. Condition:** • Replace: Unit number one. Entry door to dining room is missing. Recommend replacement.
